ANGKOR VAT

INDIA'S CONTRIBUTION IN CONSERVATION

MEMOIRS OF THE
ARCHAEOLOGICAL SURVEY OF INDIA
NO. 91

B. NARASIMHAIAH

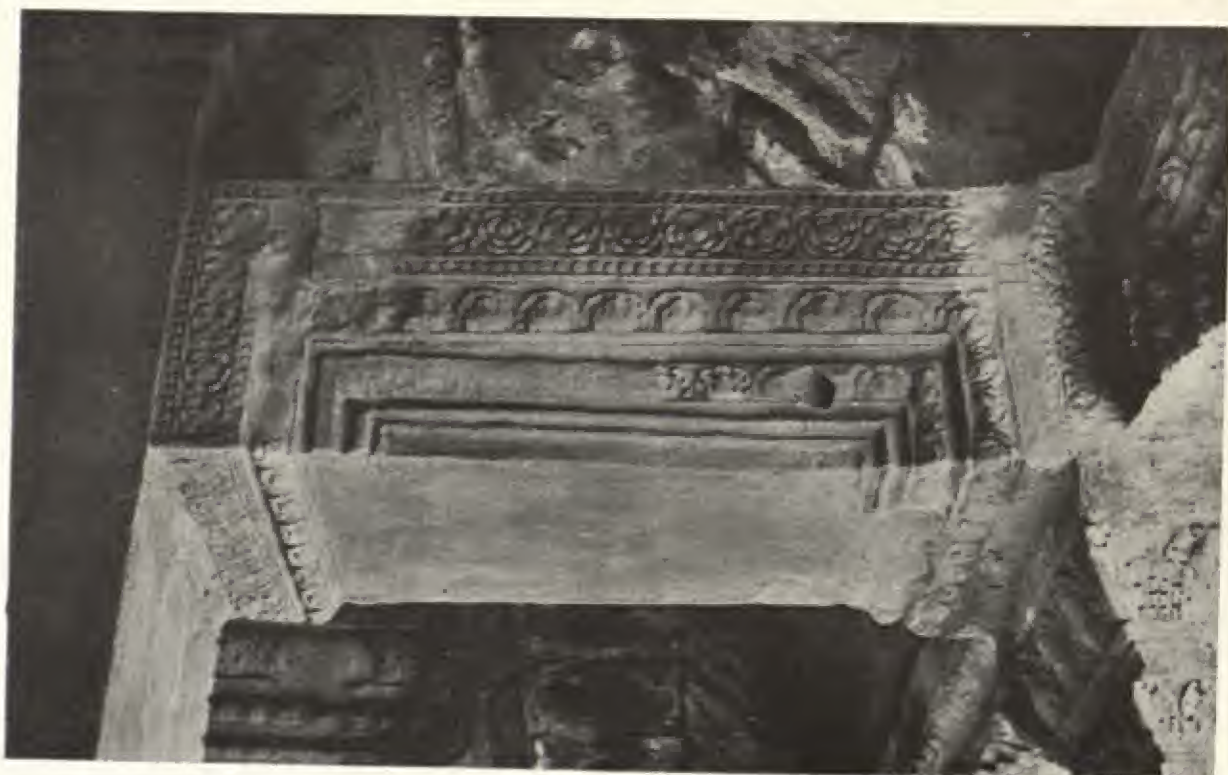
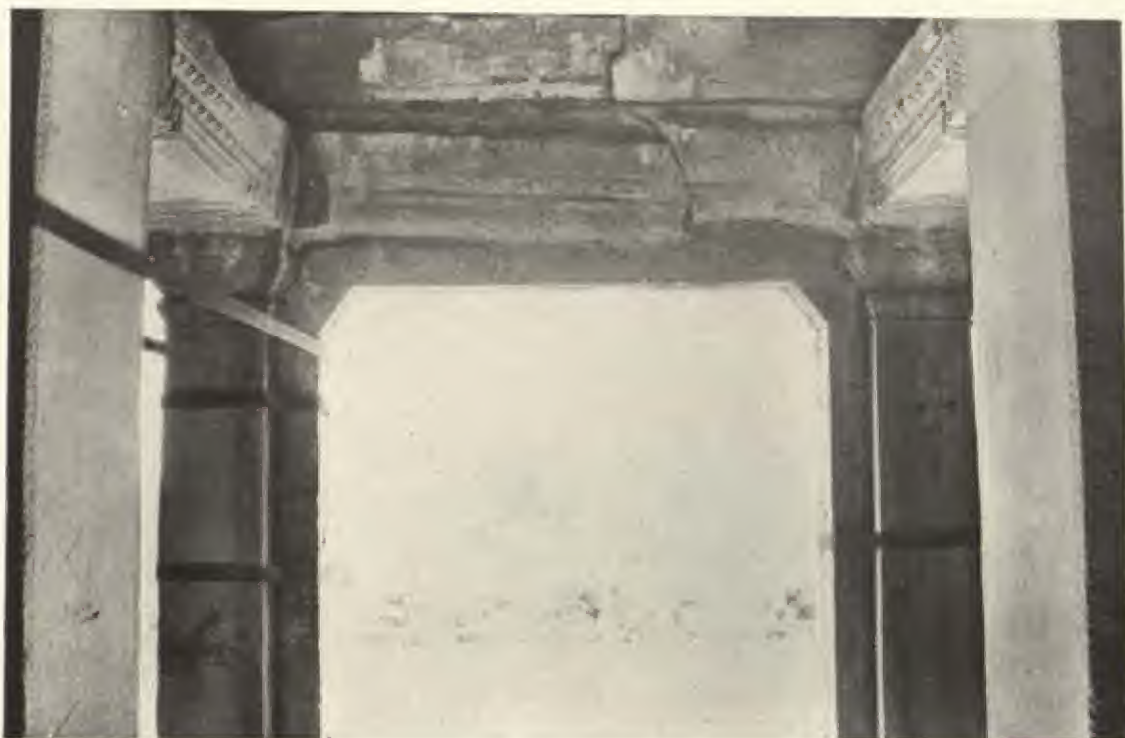
Third Enclosure : Eastern Gallery. A, before and B, after conservation

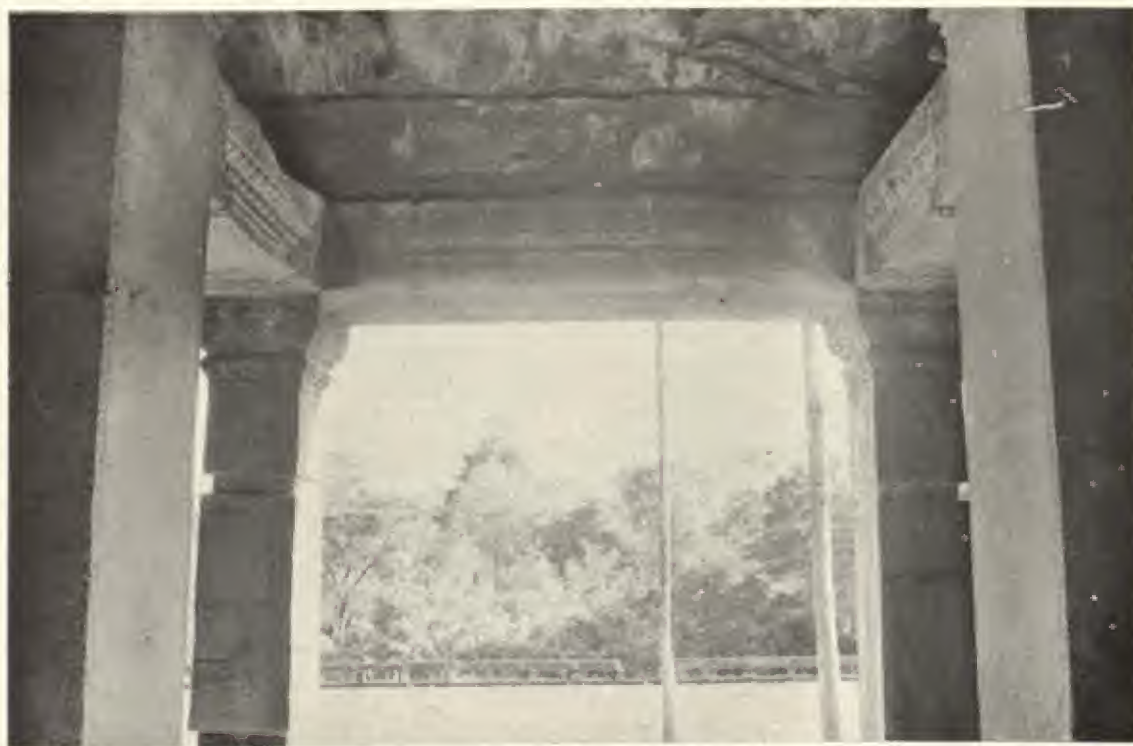
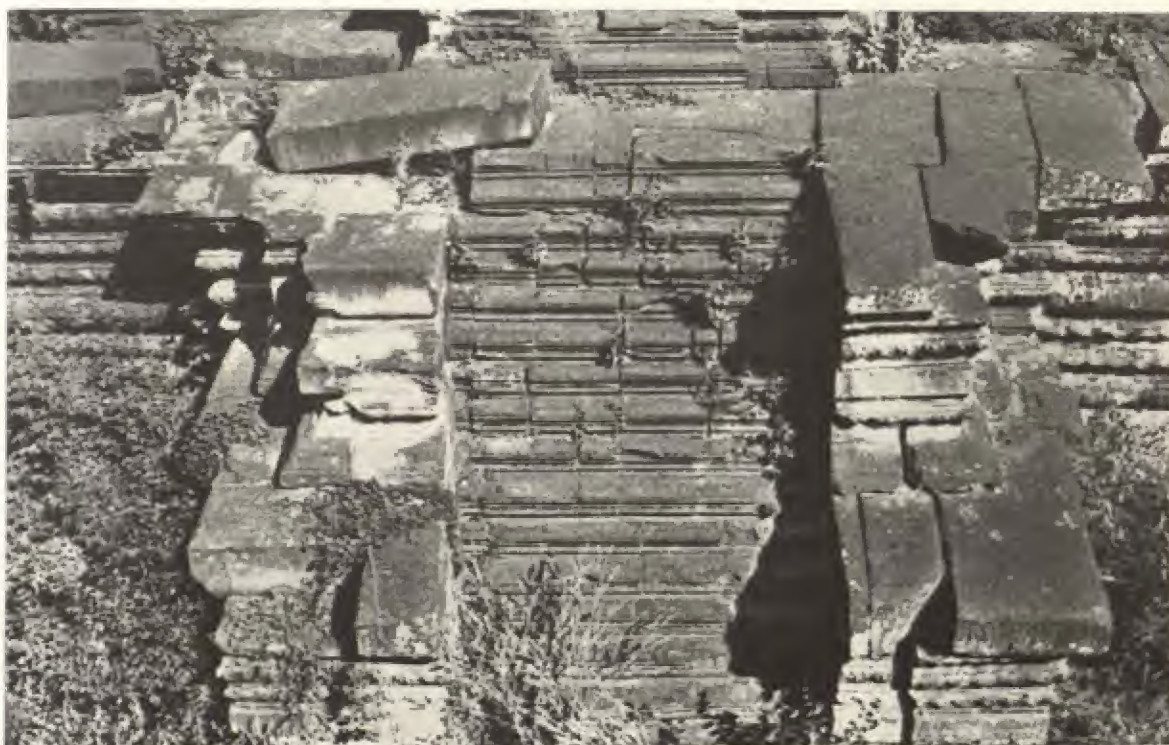
Third Enclosure : Eastern Gallery, A, before and B, after conservation

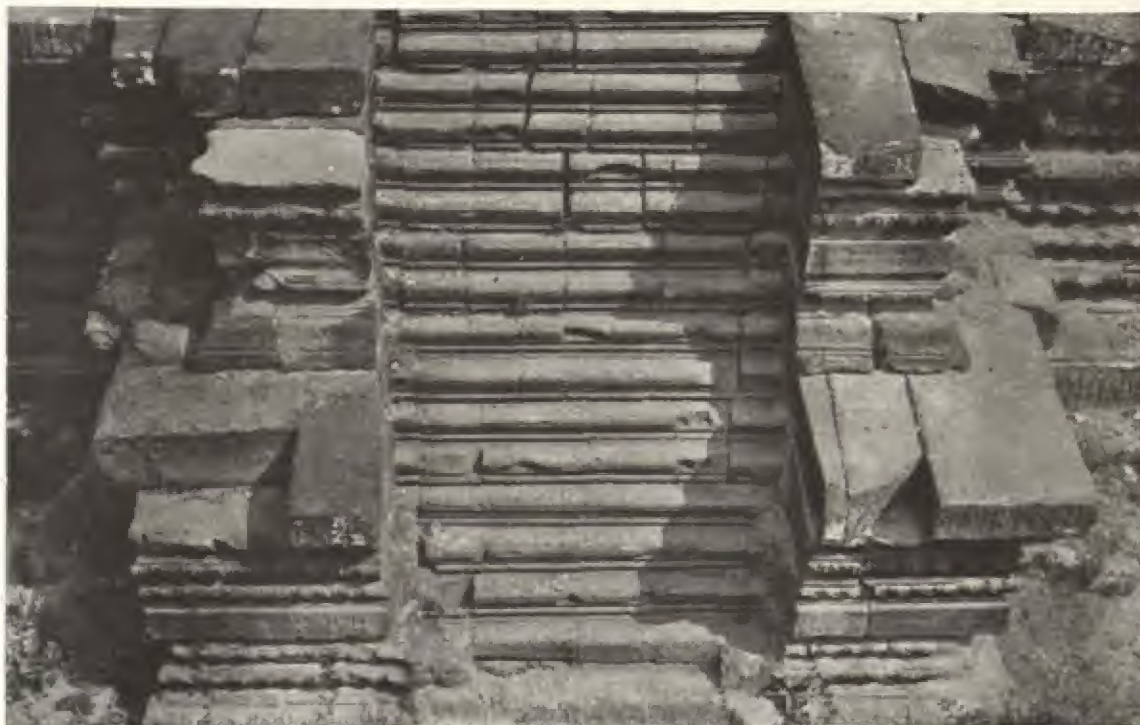
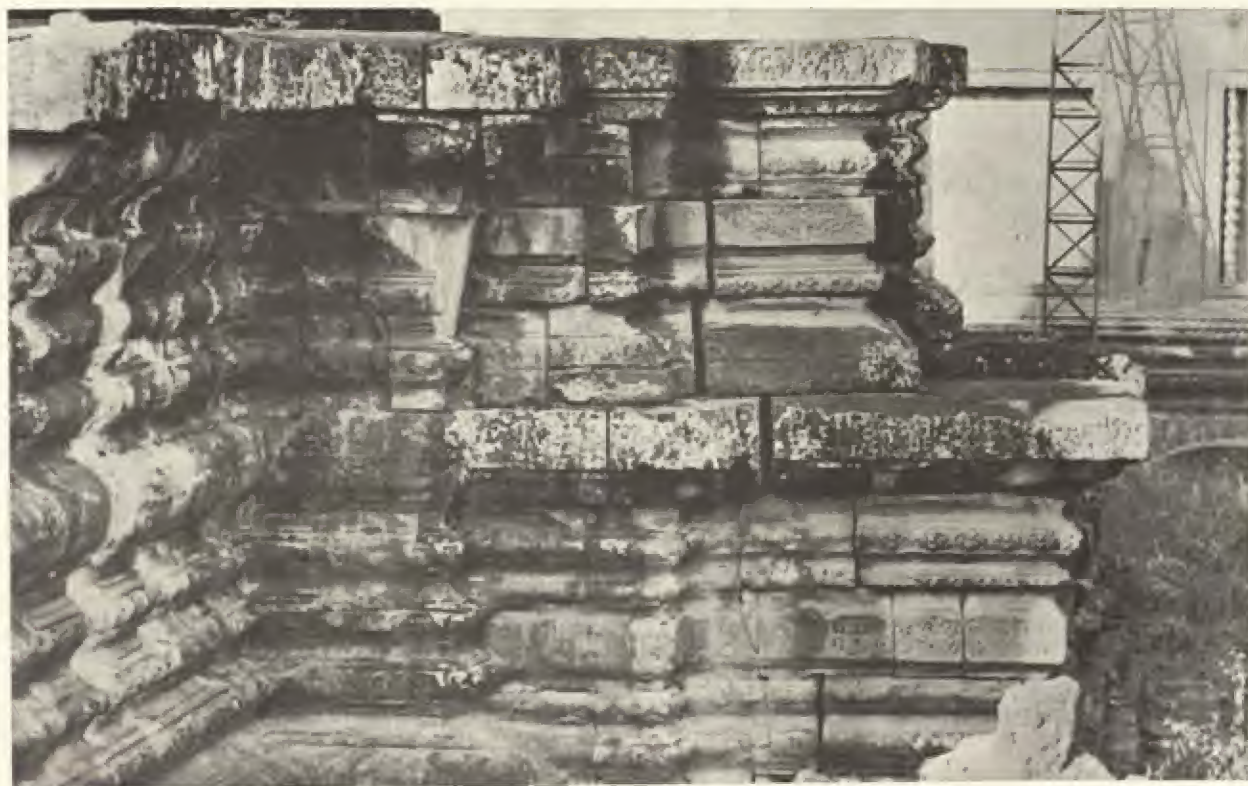
*Southern Library between Second and Third Enclosures : southern stepped entrance,
A, before and B, after conservation*

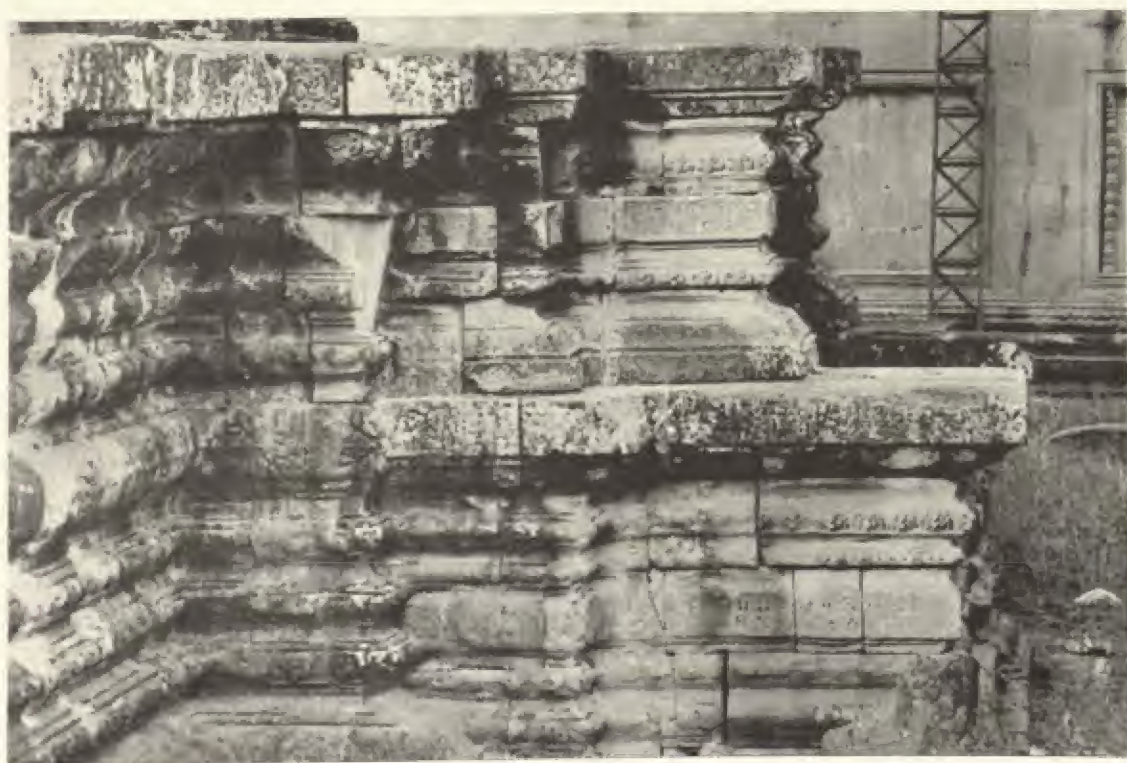
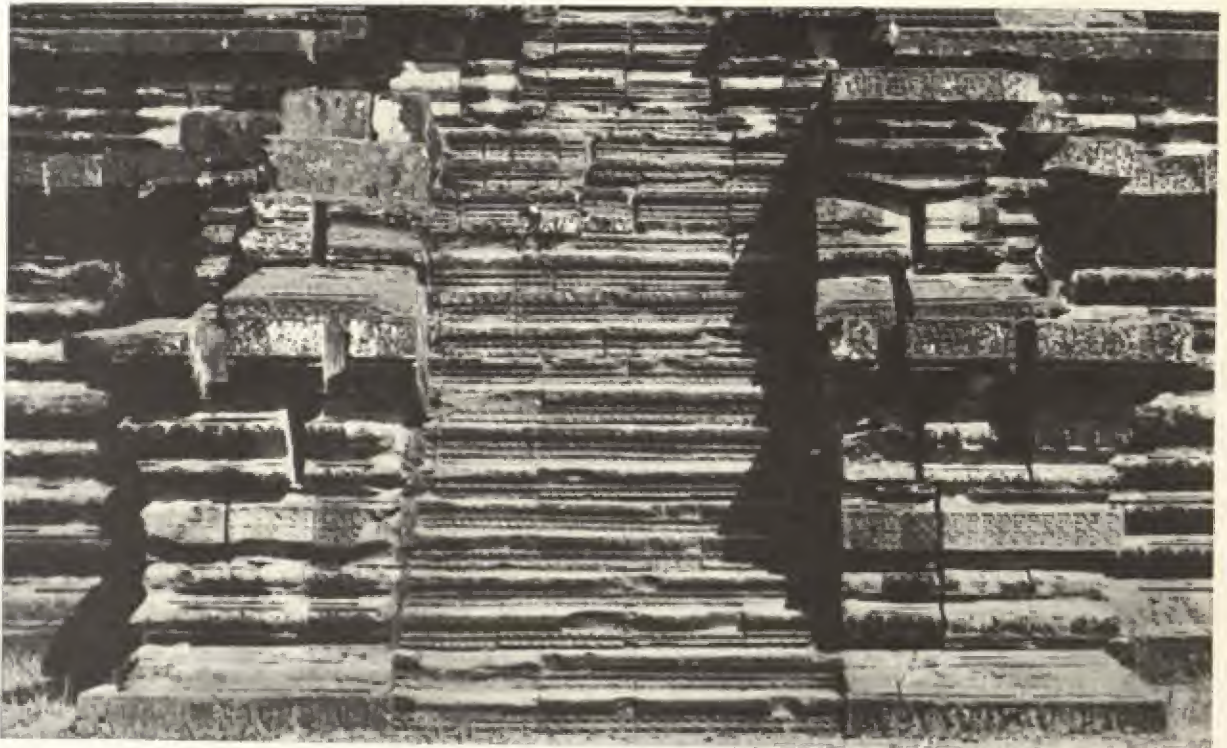
*Southern Library between Second and Third Enclosures : northern stepped entrance,
A, before and B, after conservation*

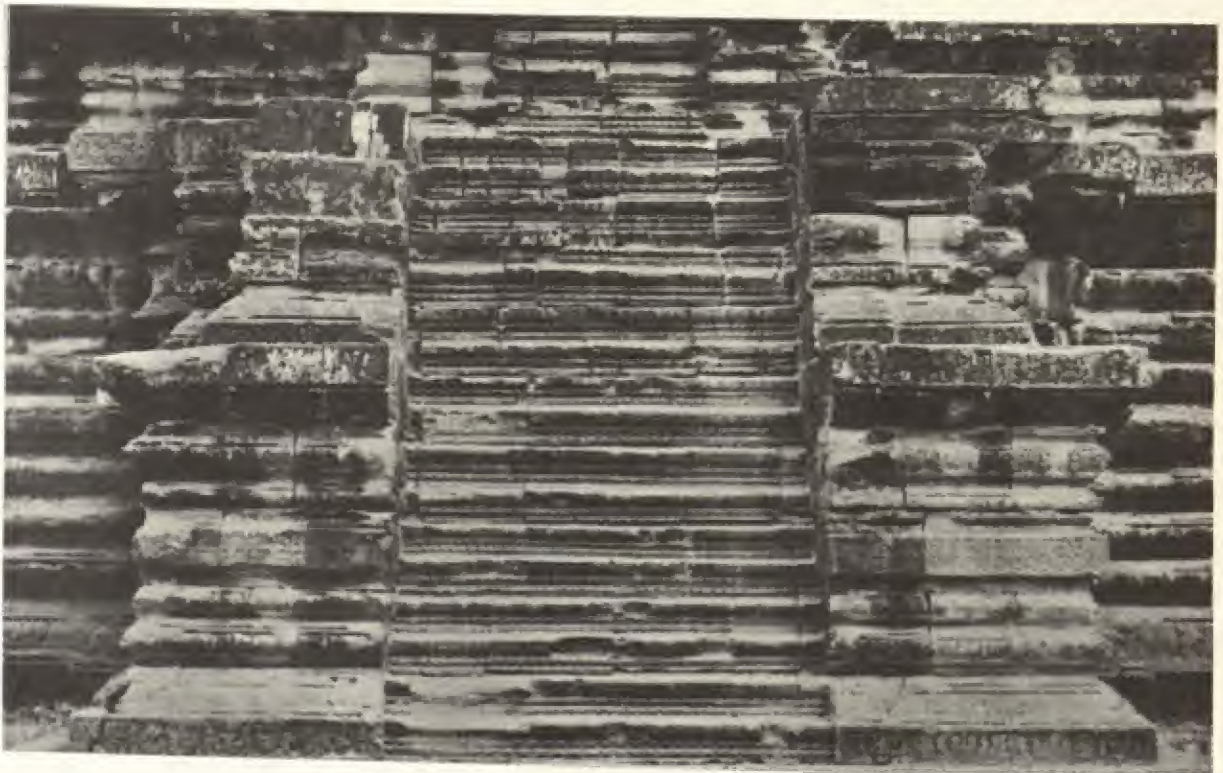
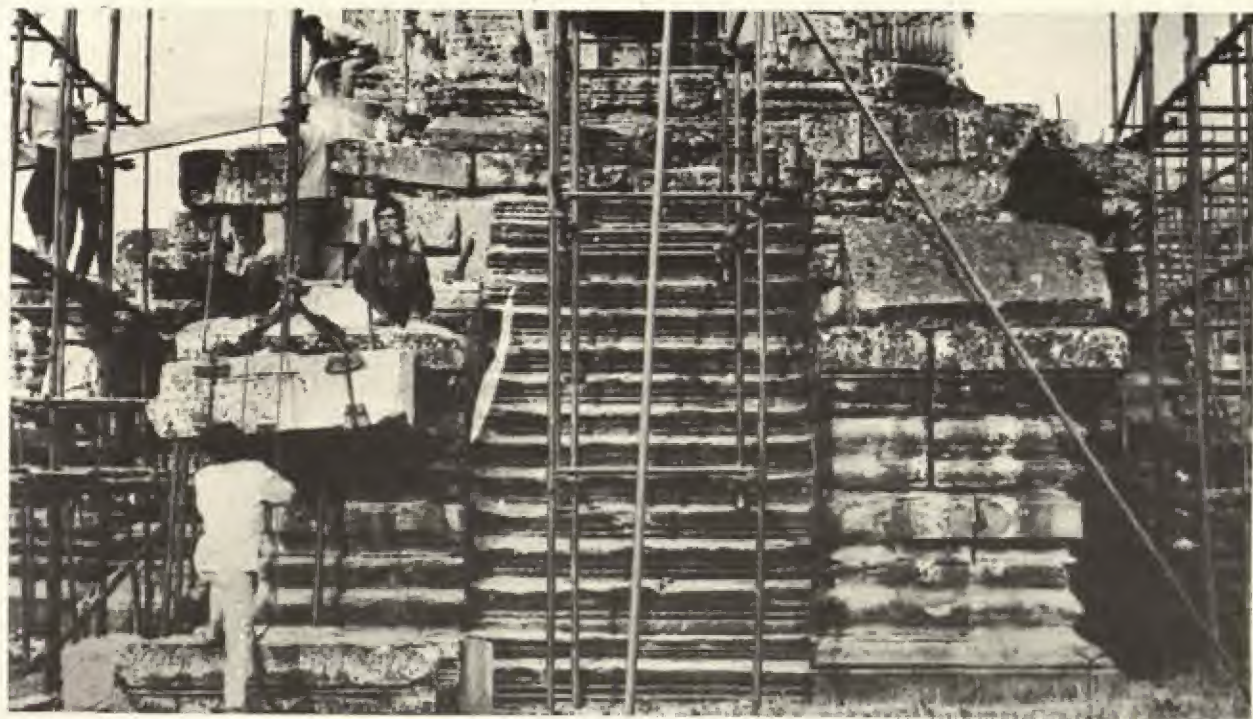
*Northern Library between Second and Third Enclosures : southern stepped entrance,
A, before and B, after conservation*

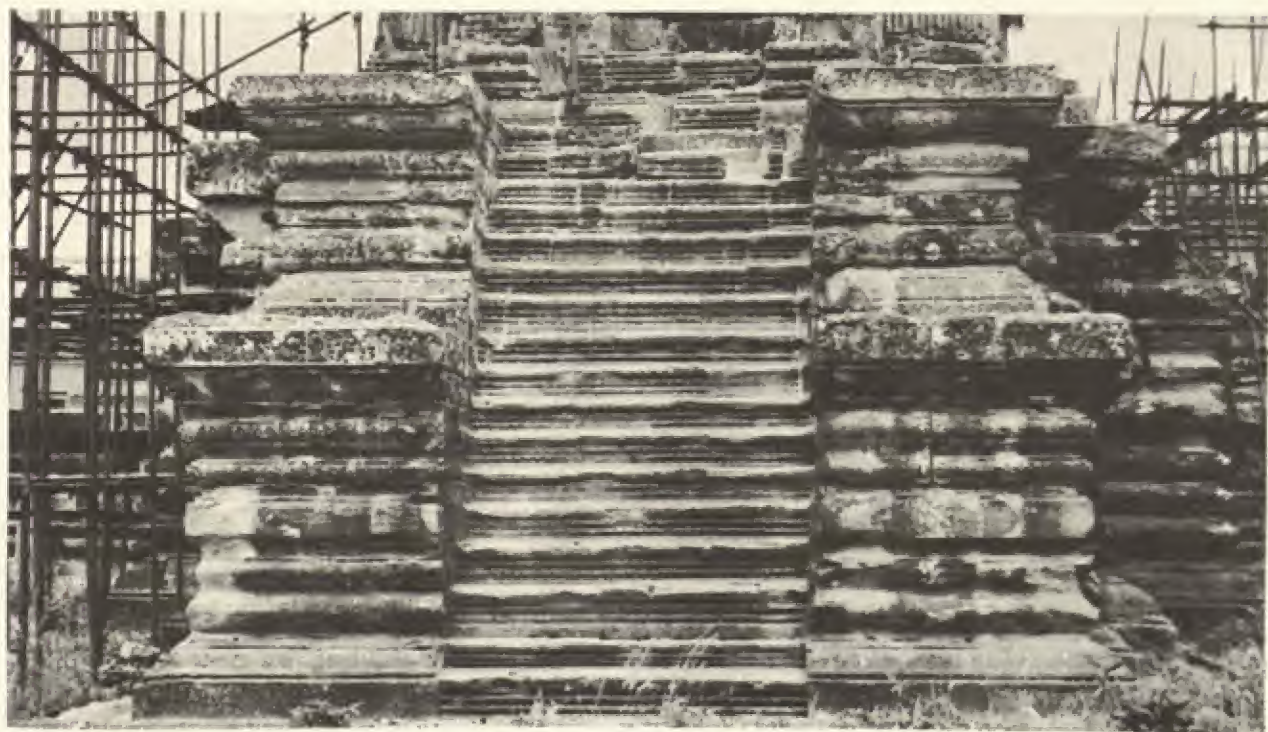
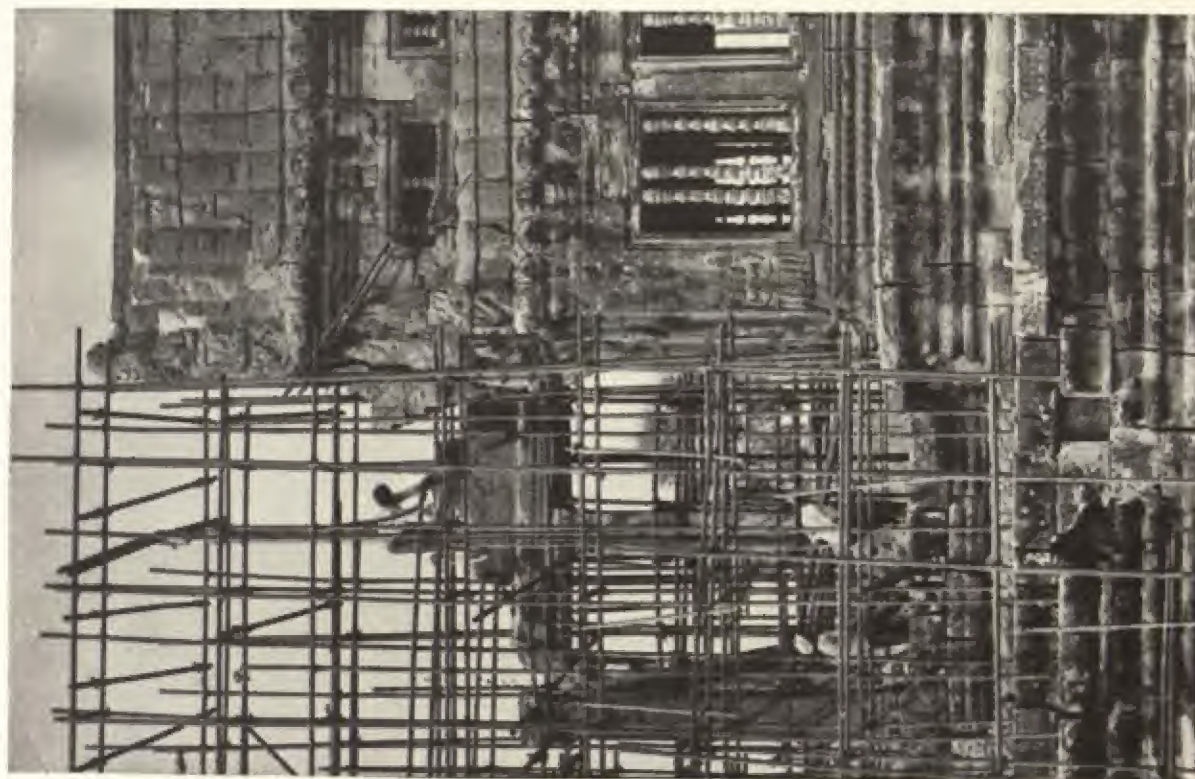
*Northern Library between Second and Third Enclosures : eastern stepped entrance,
A, during and B, after conservation*

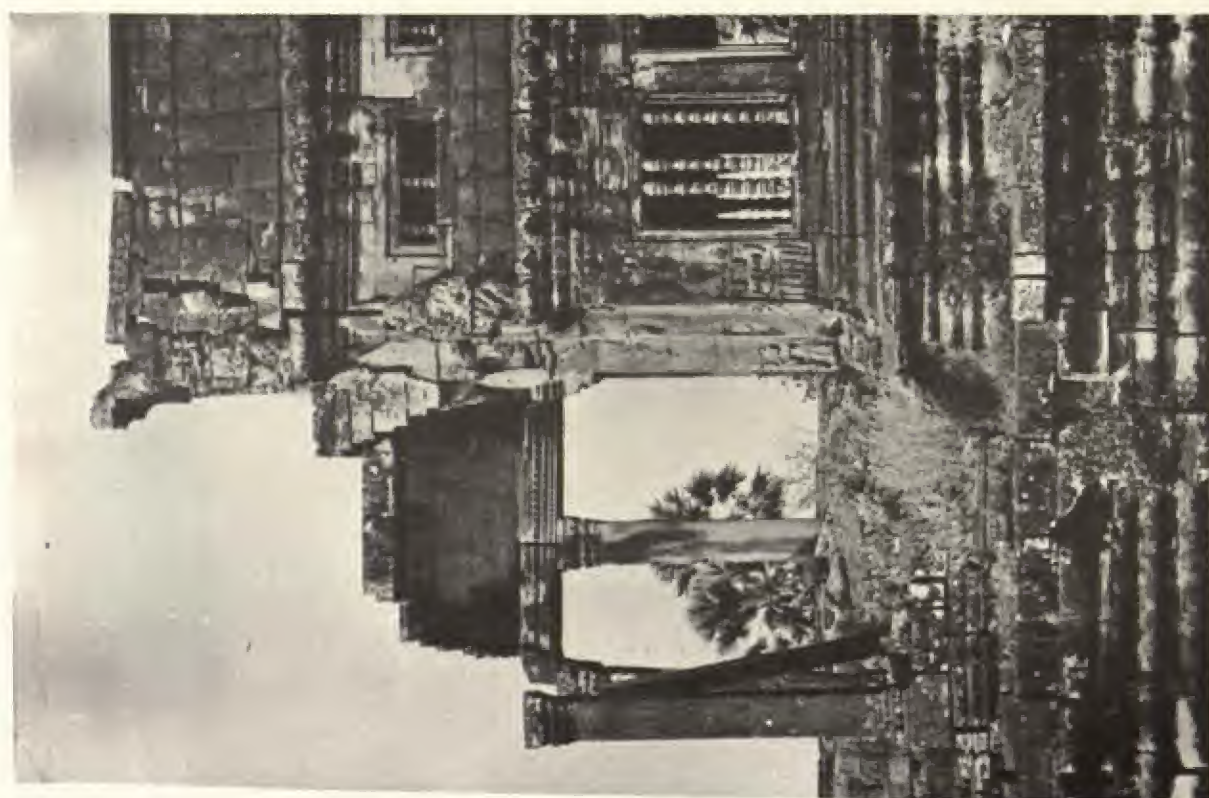
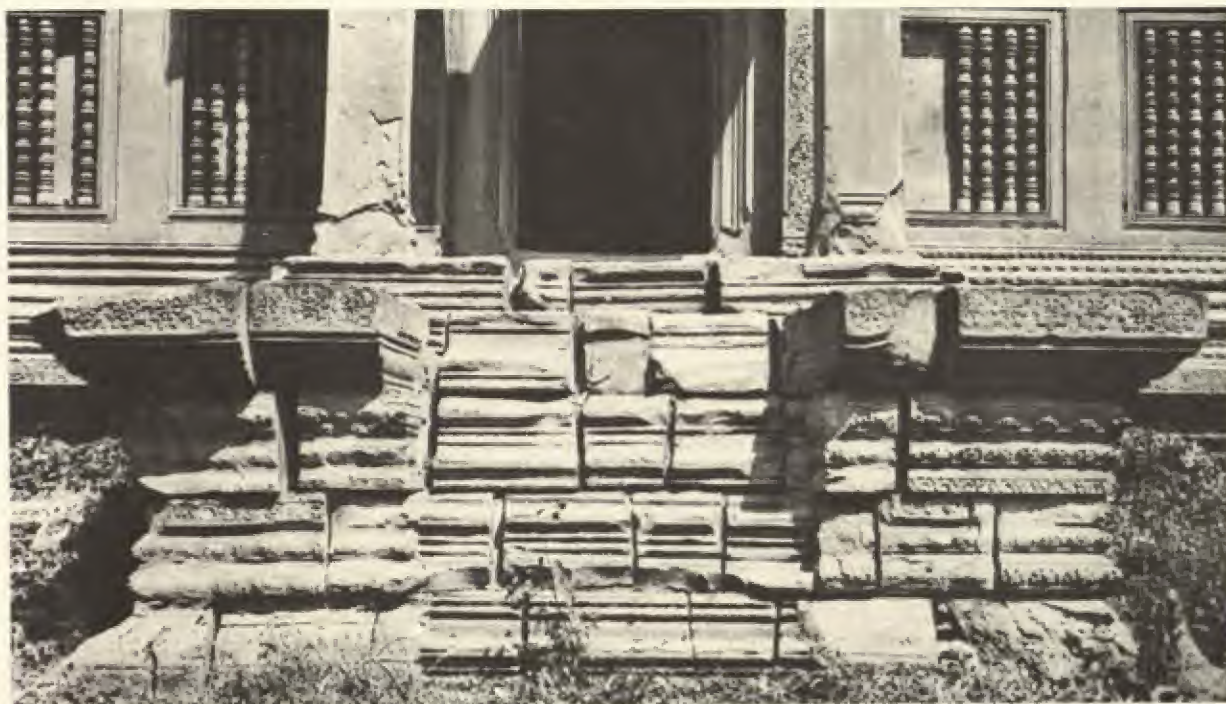
Northern Library between Second and Third Enclosures: western topmost torana, A, before and B, after conservation

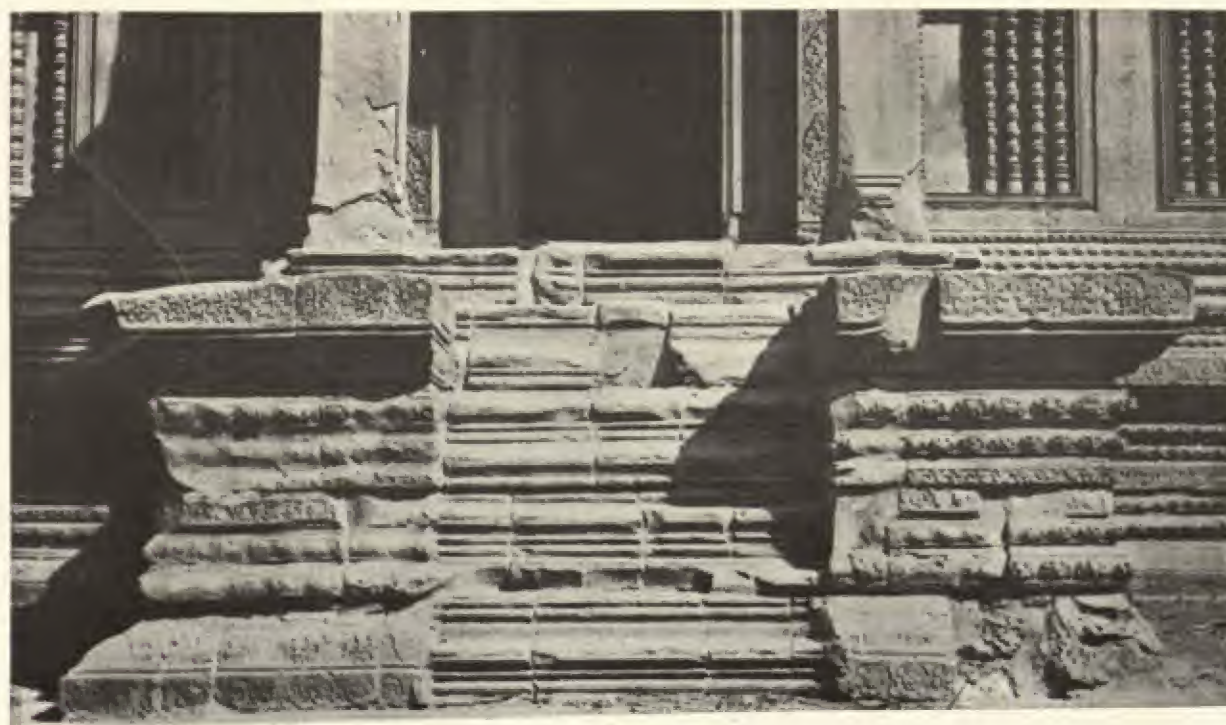
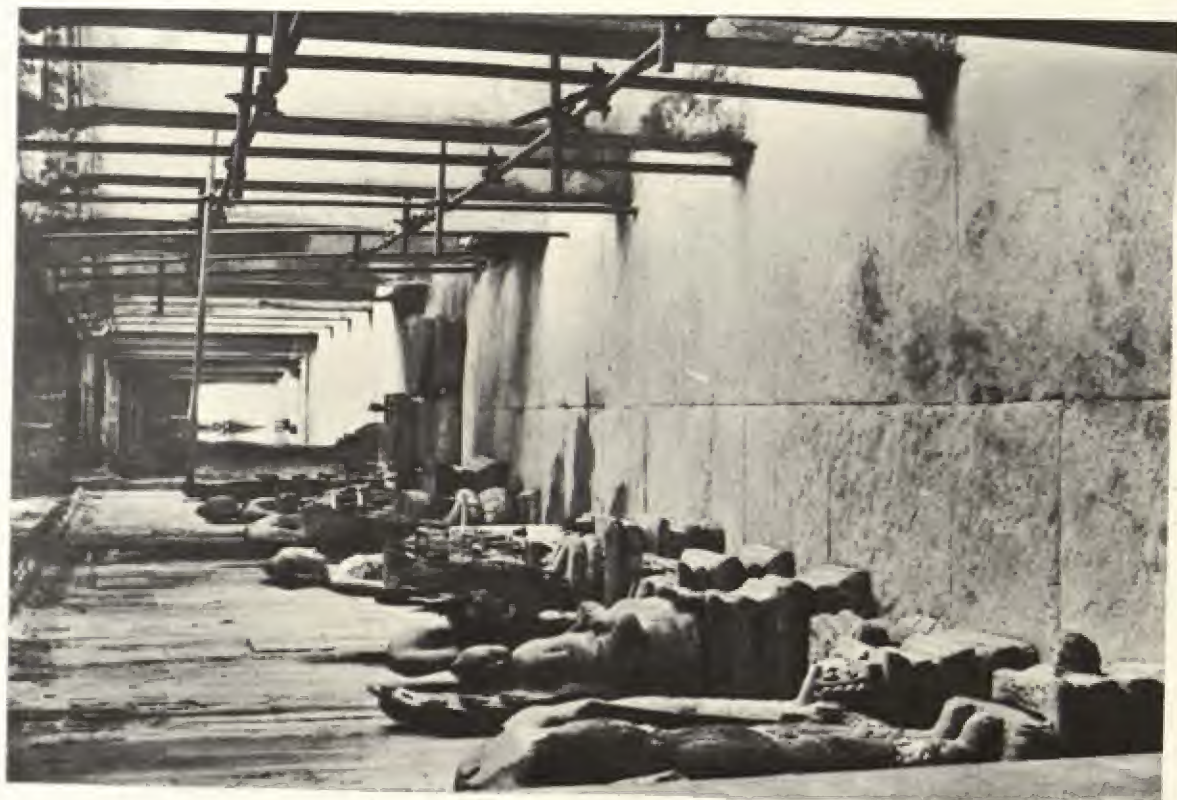
*Antechamber between Second and Third Enclosures: southern stepped entrance,
A, before and B, after conservation*

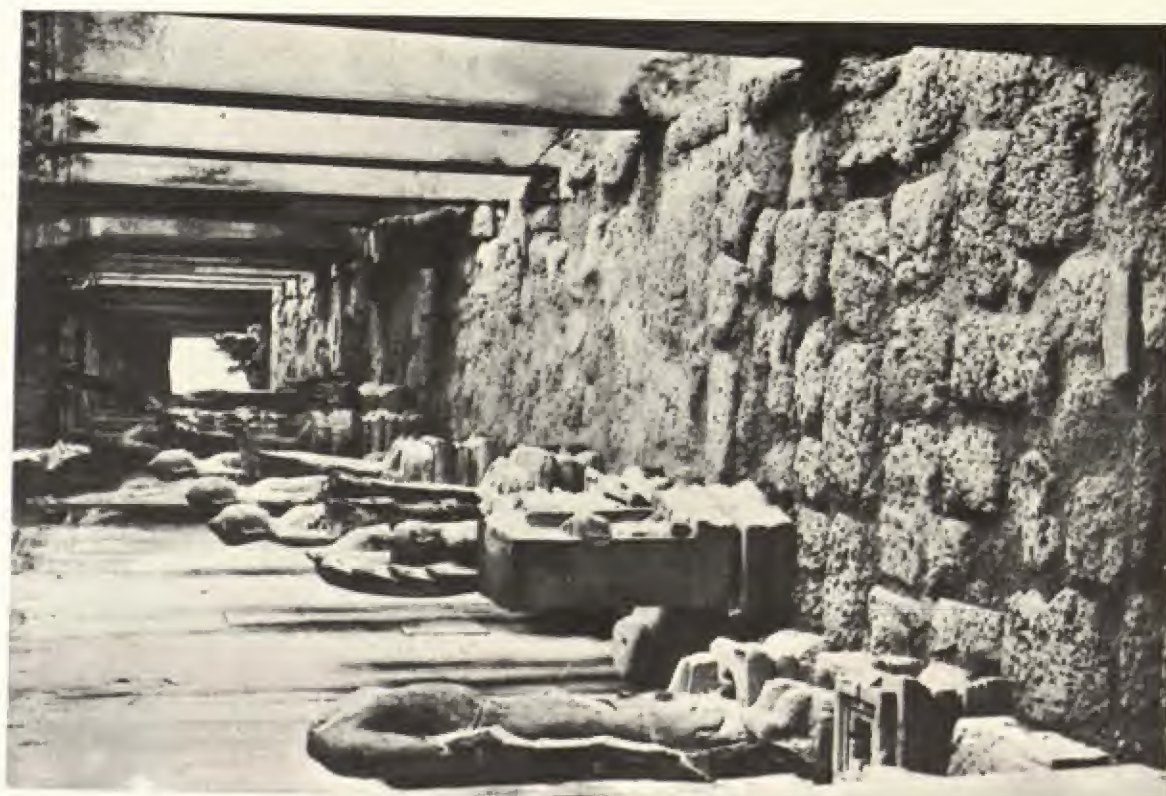
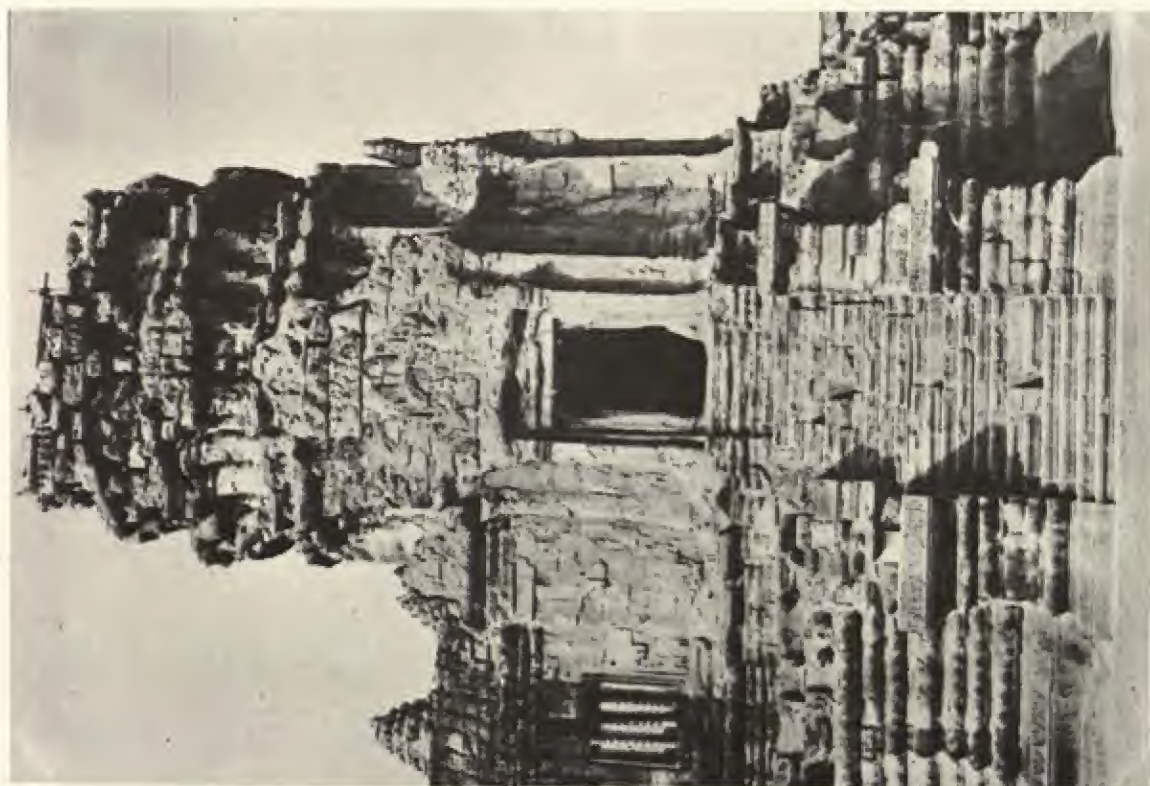
Antechamber between Second and Third Enclosures: Southern Gallery, A, before and B, after conservation

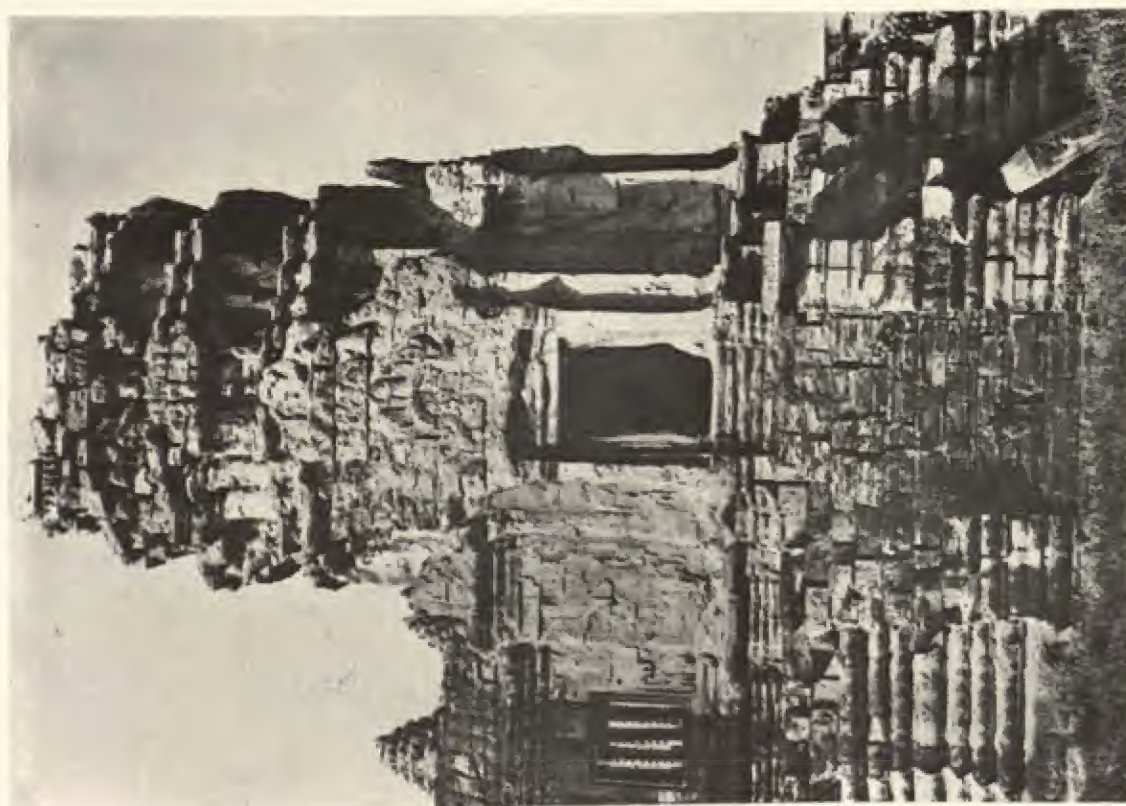
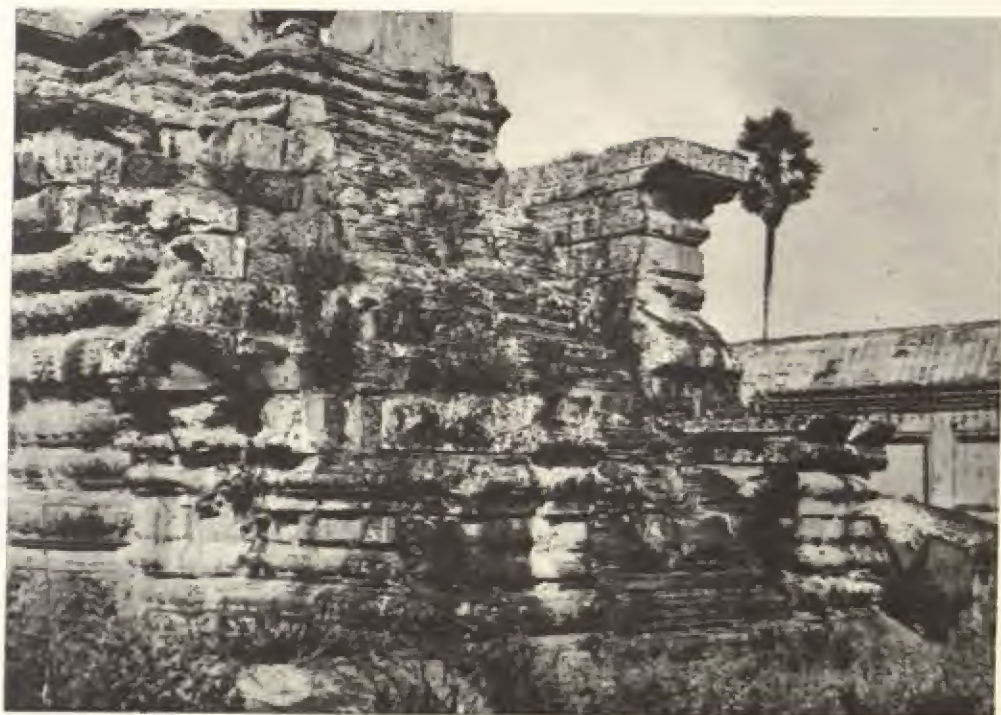
Second Enclosure : eastern stepped entrance at north corner, A, before and B, after conservation

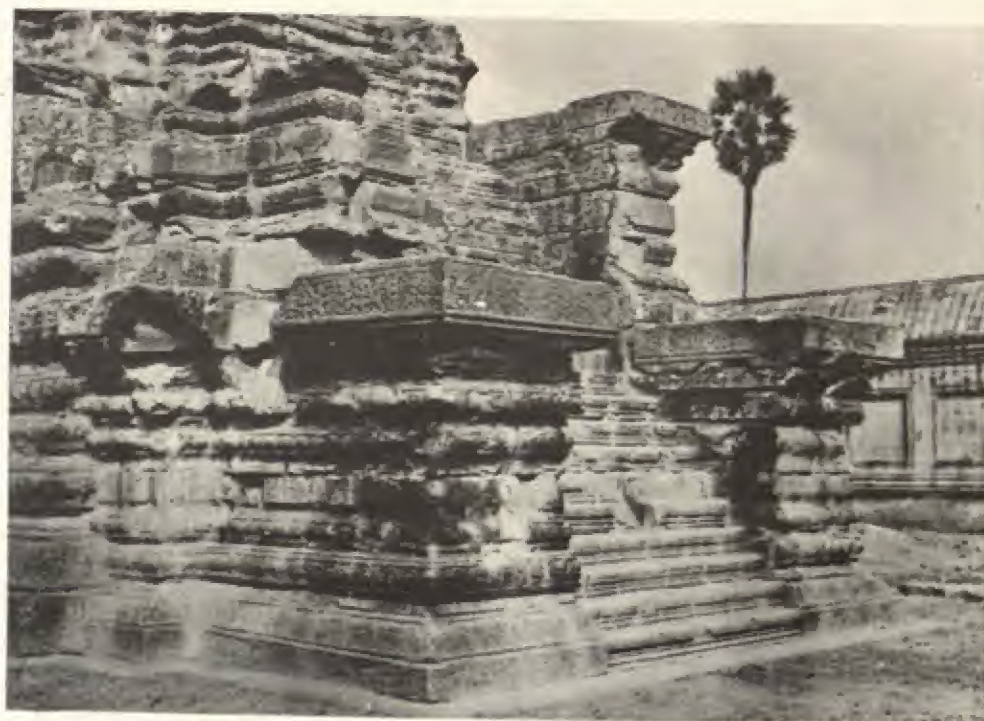
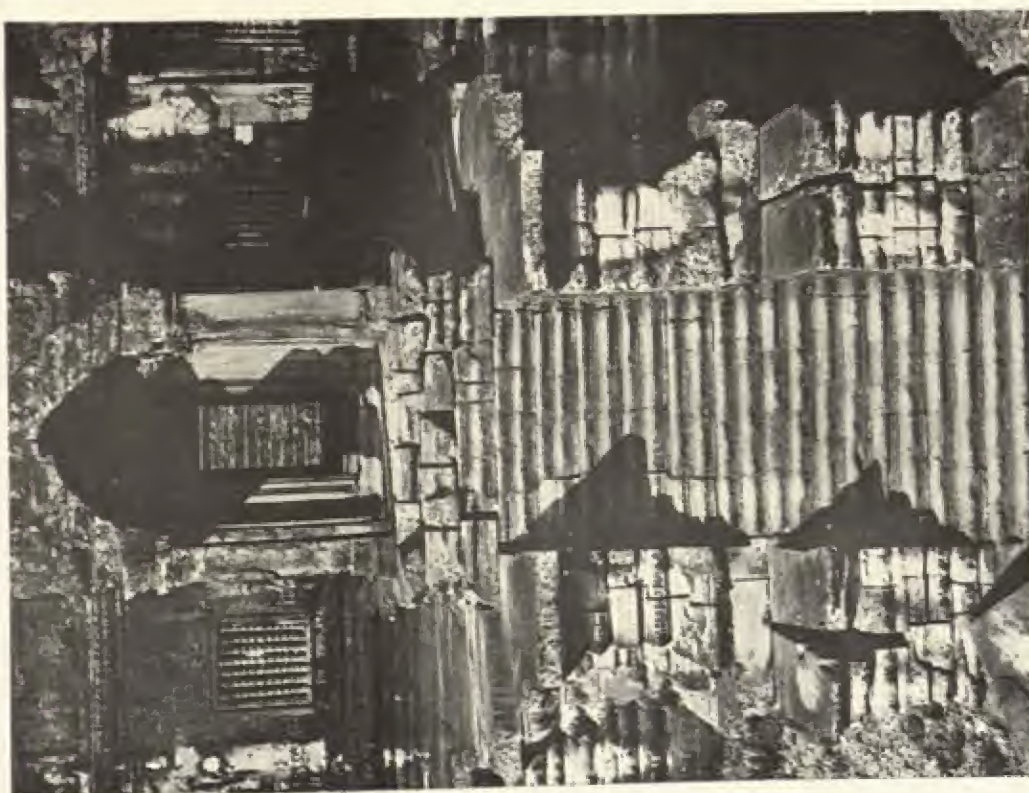
Second Enclosure : eastern stepped entrance at north corner, A, before and B, after conservation

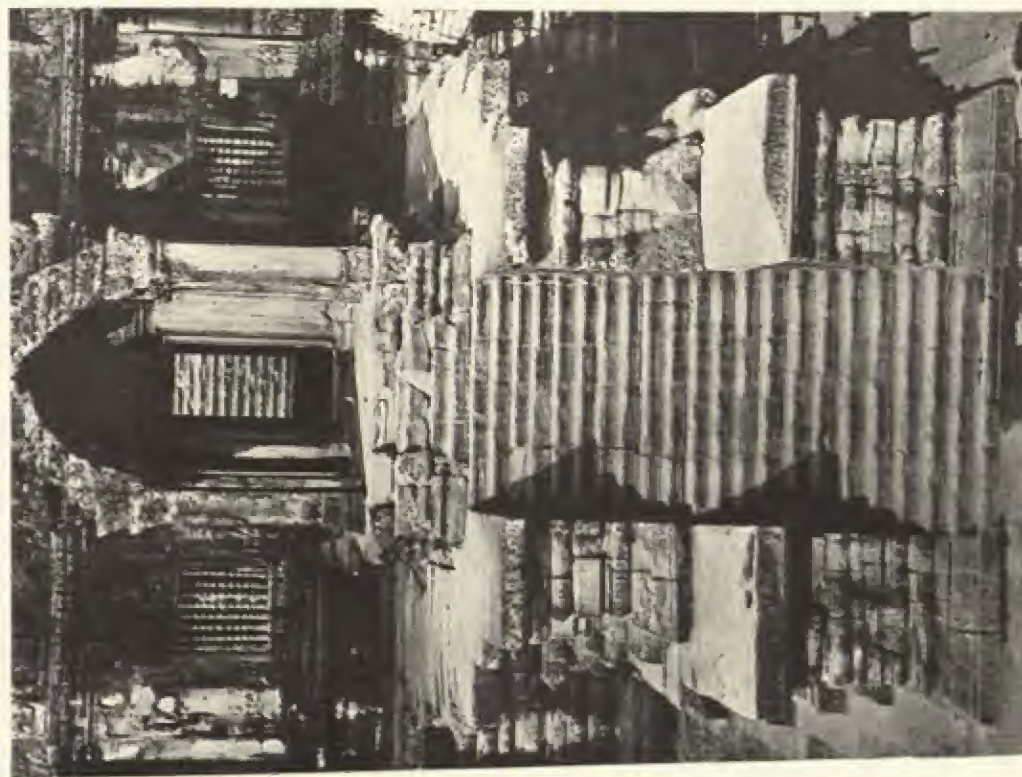
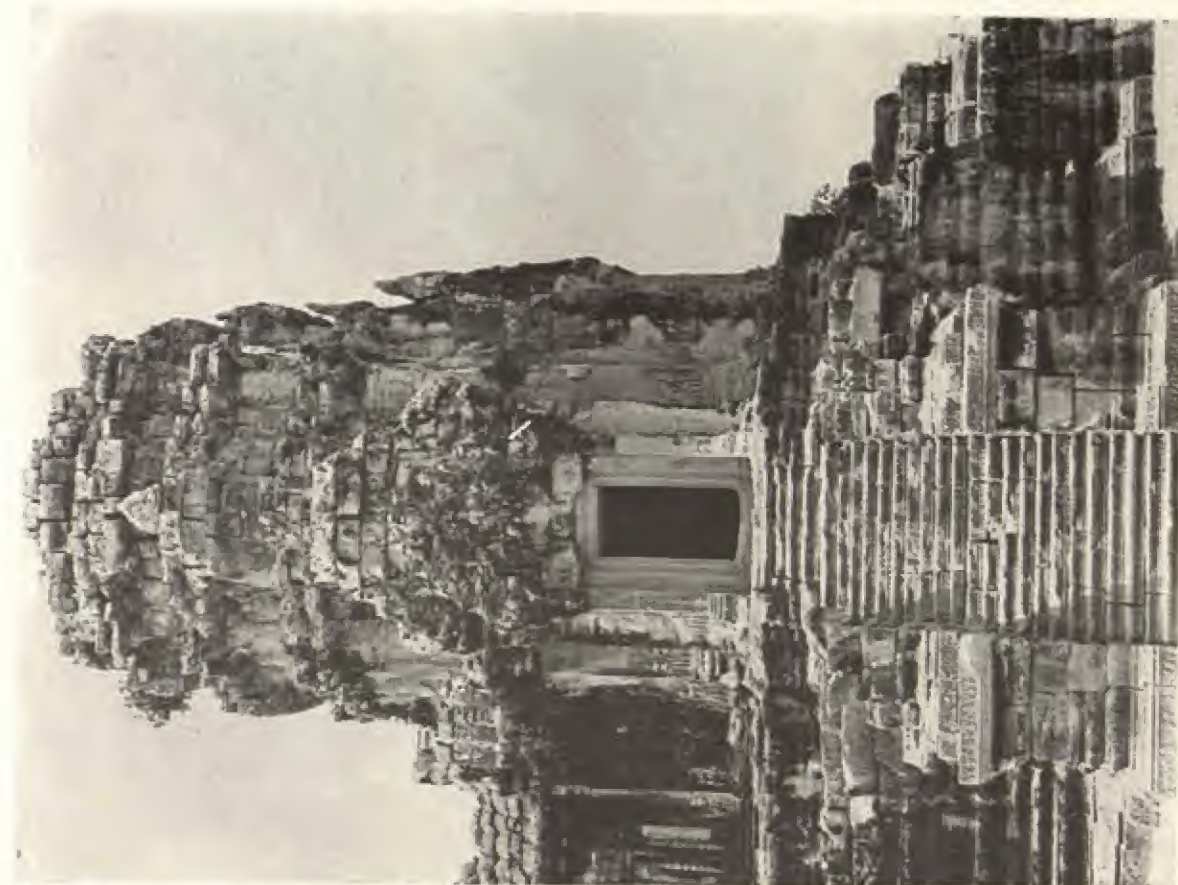
Second Enclosure : eastern central entrance , A, before and B, after conservation
